# LOC — WALKOVER SURVEY (TRIAL) RECORD SHEET

Unique Feature Code: <b>AM500①</b>	Site Name: <b>TETENGA</b>	Associated Feature N°: <b>②, ③ + ④</b>
Feature type: <b>AHU — IMAGE / AHU — PYRAMID</b>		
Previously noted (tick) <input checked="" type="checkbox"/>	Hunt:	Atlas:
	Shephardson:	Other: <b>ENGLERT 193</b>
Easting <b>667226</b>		Northing <b>6997202</b>
Length: <b>*</b>	Width:	Height/Depth:
Photo N°s (yes/no, include camera and batch n°s): <b>NONE</b>		
Land use: <b>PASTURE</b>	Physical Relationships: <b>NONE</b>	
Description/Interpretation: <b>IMAGE AHU TRANSFORMED INTO PYRAMIDAL AHU. 2 MOAI.</b>		
Sketch: <b>* See AHU / ON ORIGINAL SURVEY FOR DIMENSIONS.</b>		
<div style="text-align: center;">

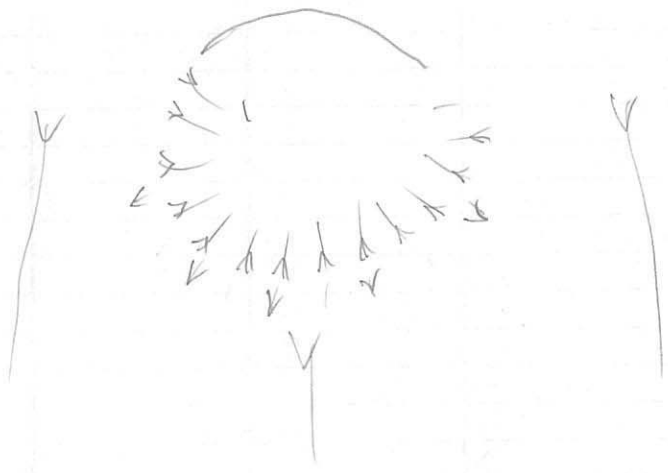
1 Feature No: (16)		2 Site Name: NONE		2 Associated Feature No(s): (19)	
3 Feature type: MANAVAI - SUNKEN / MINOR QUARRY					
4 Previously noted (tick)	Hunt:	Atlas:	Shephardson:	Other:	
5 Easting 0667767		Northing 6997403			
6 Length: 11m *		7 Width: 9m *		8 Height/Depth: 2.3	
9 Photo No(s) (yes/no): YES 0796					
10 Land use: PASTURE / SCRUB		11 Physical Relationships: ROCK MULCH			
12 Description/Interpretation: SUB-CIRCULAR HOLLOW WITH DOWNSLOPE UPGRADE. ANGULAR, QUARRIED ROCK FACE ON UPSLOPE SIDE. NO STRUCTURE					
13 Sketch:

14 Significance: MEDIUM - POSSIBLE DUAL USE					
15 Visibility:		16 Date: 14/1/13		17 Initials: SDH, MBT, RDW

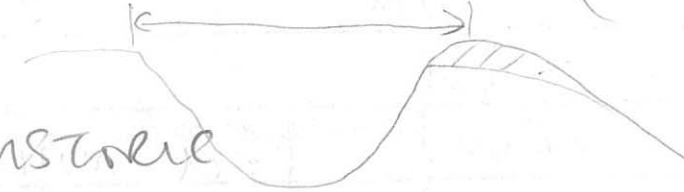
Feature no: (16)		Site Name:		
18 Additional Comments:				
<p>* HORIZONTAL MEASUREMENTS TAKEN FROM TOP OF UPGRADE:</p> <p>ANS:</p>

<p>PREMSTONE</p> <p>EXCAVATION PERHAPS FACILITATED BY INTERFACE BETWEEN FLOW LAVA AND SPATTER SCORIA</p>				
19 Moai preservation/ threats				
Issue level	Major	Regular	Minor	None
Erosion due to rainwater				
Other forms of weathering				
Loss of features				
Fissures				
Cracks				
Major cracks				
Lichen				
Silica Deposits				
Graffiti				
Bird Excrement				
Deposition processes				
Marine Spray				
Darkening due to humidity				
Saline efflorescence				
Moss				
Pasture and seeds				
Exposition to birds				
Cavities				
Lamination				
Precarious location				
Livestock

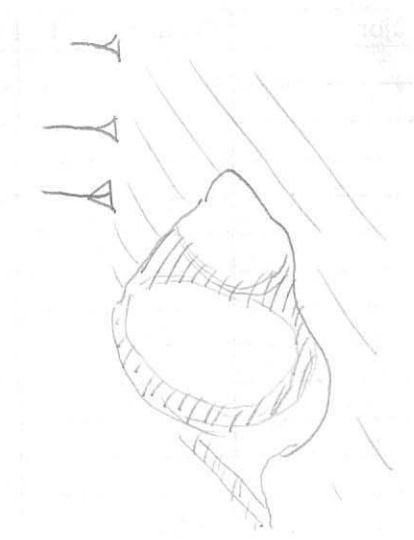
1 Feature No: (22)		2 Site Name: NONE		3 Associated Feature N <sup>o</sup> (s): (24) (21) (23)	
3 Feature type: MANAVAI - RAISED / COMPLEX					
4 Previously noted ( tick )	Hunt:	Atlas:	Shephardson:	Other:	
X					
5 Easting: 667944		6 Northing: 6997511			
6 Length: 10.2m		7 Width: 8.3m		8 Height/Depth: 0.8m (outside)	
9 Photo N <sup>o</sup> (s) (yes/no): yes					
10 Land use: pasture / rough scrub			11 Physical Relationships: cave on upslope side		
12 Description/Interpretation:					
Complex of probably 3 (def. 2) manavai cells, one larger than others. Nested in ? quarried terracing of lava flow. SKINS OF MOSTLY SS CELLS COMPRISE / ROUGHLY FITTED BOWLER UNDRESSED LOCAL FLOW LAVA. FILLER FILLED WITH FIST-SIZED CLASTS					
13 Sketch:

14 Significance: MEDIUM - GOOD EXAMPLE OF COMMON TYPE					
15 Visibility: MEDIUM		16 Date: 14/1/13		17 Initials: RDW, MGT

Feature no: (22)		Site Name:		
18 Additional Comments:				
Full of vegetation, so impossible to measure internal depth				
CAVE: AT THE BACK OF INNERMOST CELL				
19 Moai preservation/ threats				
Issue level	Major	Regular	Minor	None
Erosion due to rainwater				
Other forms of weathering				
Loss of features				
Fissures				
Cracks				
Major cracks				
Lichen				
Silica Deposits				
Graffiti				
Bird Excrement				
Deposition processes				
Marine Spray				
Darkening due to humidity				
Saline efflorescence				
Moss				
Pasture and seeds				
Exposition to birds				
Cavities				
Lamination				
Precarious location				
Livestock

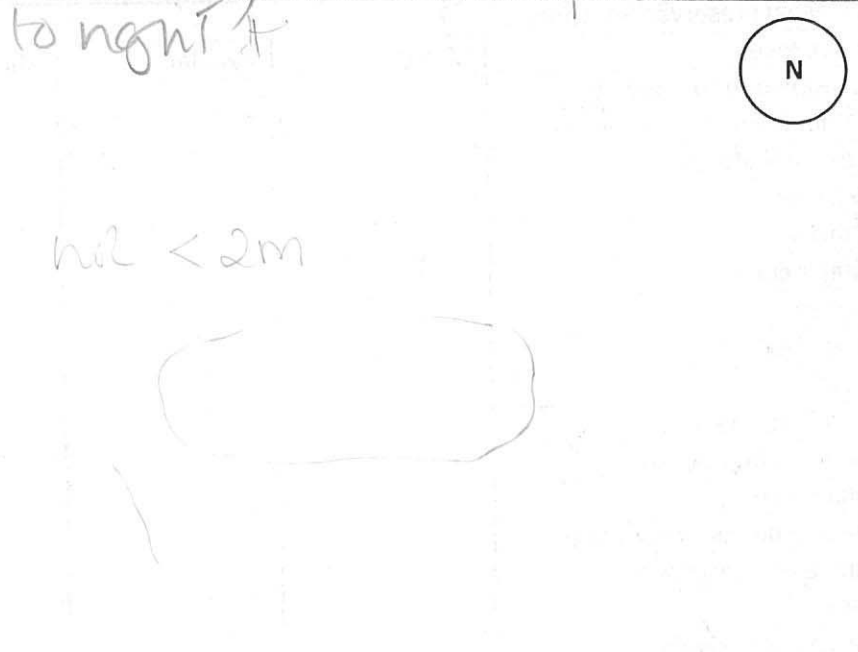
1 Feature No: 65	2 Site Name:	2 Associated Feature N <sup>o</sup> (s): 66, 60-64, 66
3 Feature type: BOATHOUSE/HALL PAENGA		
4 Previously noted (tick) <input checked="" type="checkbox"/>	Hunt:	Atlas: Shephardson: Other: uncluster
5 Easting 0668851	Northing 6997832	
6 Length: > 3*	7 Width: 0.5 (at end no other width remain)	8 Height/Depth: 0.10 m
9 Photo N <sup>o</sup> (s) (yes/no): 251		
10 Land use: SCRUB PASTURE	11 Physical Relationships: NONE	
12 Description/Interpretation: Ruinous boathouse with with right hand end only remaining with pu paenga in place and port pavement in front. Around it displaced pu paenga some of Tereraka type stone. Boat house front side looks out on sea, ahu (feature 37) to a toa in general view to right.		
13 Sketch:

14 Significance: High - part of complex close to Moai		
15 Visibility: LOW	16 Date: 23 JAN/2013	17 Initials: RW SH FP EB

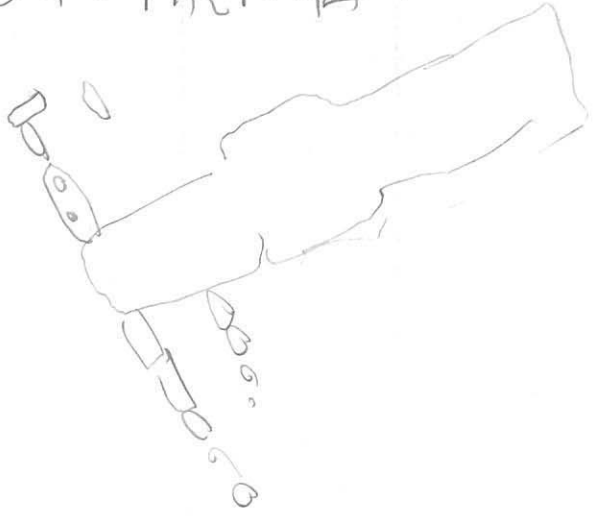
1 Feature No: <b>68</b>		2 Site Name:		2 Associated Feature N <sup>o</sup> (s): <b>60-66, 69, 960</b>	
3 Feature type: <b>UNIDENTIFIED STRUCTURE</b>					
4 Previously noted (tick) <input checked="" type="checkbox"/>	Hunt:	Atlas:	Shephardson:	Other:	
5 Easting <b>0668829</b>		Northing <b>6997859</b>			
6 Length: <b>7.20</b>		7 Width: <b>1.7</b>		8 Height/Depth: <b>0.46</b>	
9 Photo N <sup>o</sup> (s) (yes/no): <b>1281</b>					
10 Land use: <b>ROUGH SCRUB</b>			11 Physical Relationships: <b>69 MOAI 960</b>		
12 Description/Interpretation: <b>STRUCTURE COMPRISING SINGLE DOUBLE-SCANNED WALL TO SOUTH-SIDE OF MOAI HEAD, CONTINUED AS SINGLE LINE TO NORTH. TERMINAL AT RIGHT ANGLES TO LATTER. SCIN COMPRISING BOUNDERS 30-70 CM. FILLED WITH FIST-SIZED COBBLES. WALL TO NORTH</b>					
13 Sketch: <b>RE-USED PU PAENYA (1.09m) AND SMALLER BOLDER. TERMINAL RE-USED 9 V PAENYA</b>

14 Significance: <b>HIGH - DURING TO AREA ASSOCIATED WITH MOAI</b>
